## Archival photographs showing land use history in the Luquillo WEBB study area

### Puerto Rico WEBB Site Photographs

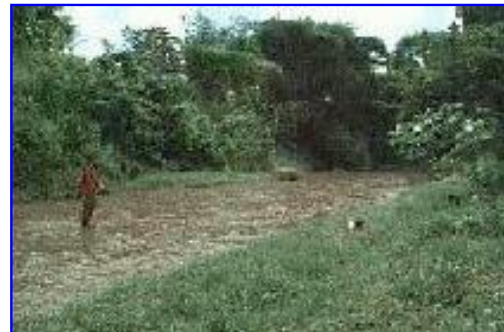
View upstream, of the Cayaguás river, at USGS station 50051310, October, 1997, showing Antioch College student using bedload sampler. Note the widened channel caused by the increased discharge resulting from Hurricane Hortense which struck Puerto Rico on September 10, 1996. Peak flow in this 26.4 square kilometer basin was 360 cubic meters per second and had a recurrence interval of 12 years. Rainfall accumulation in the watershed associated with the Hurricane exceeded 600 mm in a 24-hour period and had a recurrence interval of 100 years. The difference in recurrence intervals between peak discharge and rainfall accumulation is explained by the broad, low amplitude hydrograph that characterized the Hurricane runoff. Transport of large amounts of sand-sized bed material since the Hurricane has caused bed aggradation of 1 meter at the gaging station. Average annual suspended sediment yield measured at this station during the 1980's was 2,850 metric tonnes per square kilometer. During the 1990's, a series of low-runoff years reduced the average annual suspended sediment yield to 750 metric tonnes per square kilometer.

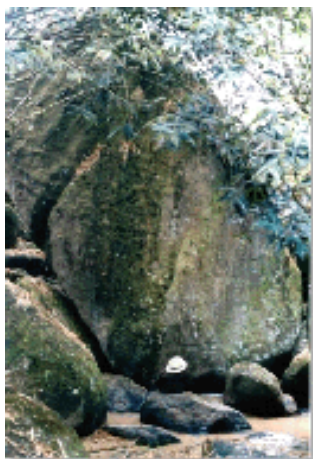
Tertiary granodiorite bedrock outcrops along the Cayaguas river channel in massive exposures known as core stones. These large deposits are derived from bedrock that has been exposed by stream channel incision during the Quaternary. Note hat for scale.

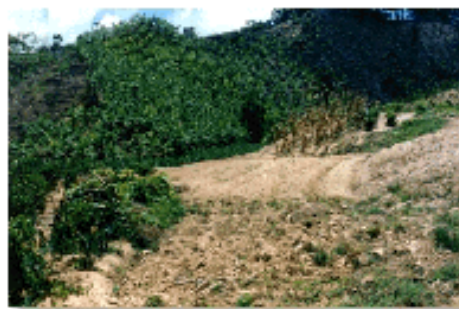
Intensive agricultural practices have contributed to high rates of soil erosion on hillslopes in the Cayaguas watershed. Bare soil exposed in the foreground has been prepared for Ñame (*Dioscorea rotundata*), a root crop. Plantains (*Musa sp.*) are visible on the hillslope in the background. The soil type is Pandura loam, an Inceptisol (Typic Eutropept). These small family-run agricultural plots are typically plowed with oxen teams, then planted and weeded by hand.

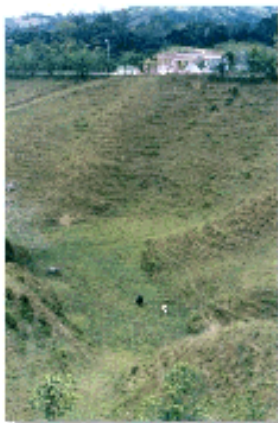
After nearly two centuries of cropping, high soil erosion rates have degraded the soil resource in the Cayaguas watershed and areas of steep hillslopes are now commonly used for grazing of cattle. On average, about 2.5 hectares of grassland are required for each grazing animal. The hillslopes in this photograph show evidence of well developed cow terraces' created by cattle moving on preferred paths parallel to the slope contour. Also visible in the photograph are amphitheatre-shaped landslide scars dating from the early 20th century which are common on hillslopes in this watershed. Scar frequency averages 109 per square kilometer of watershed surface area. Much of the soil and saprolite eroded by the mass wasting remains in storage in deposits 2 to 3 meters thick on footslopes and small (zero-order) valley bottoms such as that shown here.

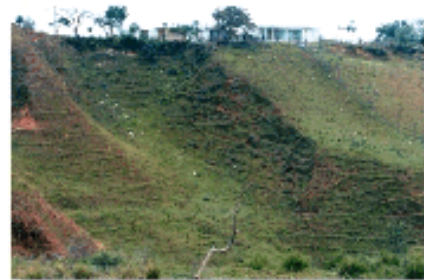
View of a landslide scar on a grass-covered hillslope in the Cayaguas watershed. Although most landslide scars in the watershed have become revegetated with pasture grasses, patches of bare soil remain and contribute to the high sediment yields of the watershed.

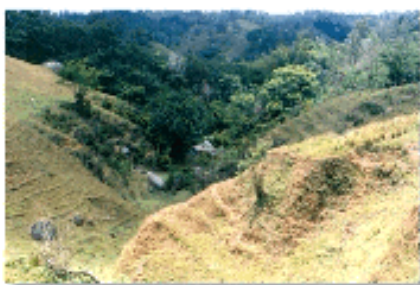
A typical view of the Cayaguas watershed showing patchwork of secondary forest and heavily-grazed pasture. Corestones, 2 to 3 meters in diameter, are visible along the floor of this ephemeral stream valley.

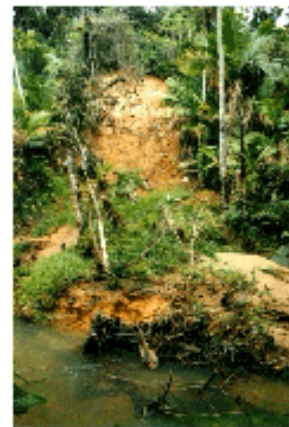
A landslide scar associated with Hurricane Hortense rainfall of September 10, 1996. The 600 mm storm triggered numerous landslides such as this one, which delivered about 300 cubic meters of soil and saprolite directly to the Icacos river channel in the Luquillo Experimental Forest. Landslides are the source of most of the average annual suspended sediment yield, 525 metric tonnes per square kilometer, for this forested 3.26 square kilometer watershed.

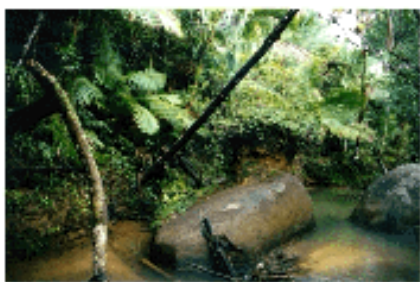
View of the Icacos river near the USGS gaging station (50075000), in the Luquillo Experimental Forest, showing large core stones in the channel. A vegetated cap of saprolite rests on top of the core stone in the center of the photograph. The saprolite presence attests to the brevity of peak discharges in this small (3.26 square kilometer) watershed where high discharge events are not uncommon but sustained flow is measured in minutes to a few hours only. The saprolite deposit, first noted more than 10 years ago, has therefore not been eroded, despite mean annual runoff of 3.9 meters.

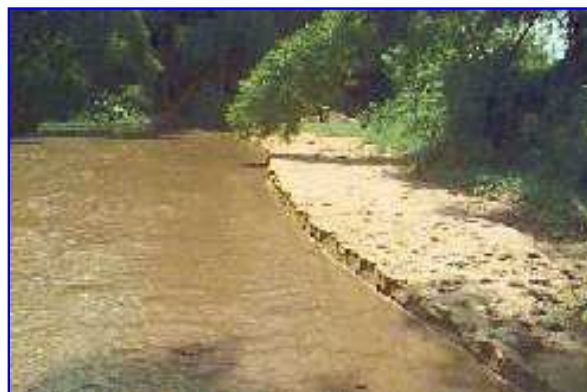
View upstream, of the Cayaguas river, at USGS station 50051310.

This river drains a 26.6 km<sup>2</sup> area south of San Lorenzo, Puerto Rico, and is a tributary of the Río Grande de Loíza. Bedrock in the watershed is Upper Cretaceous granodiorite, which weathers to sand and clay, providing an ample sediment load transported along the bed and in suspension. Mean annual runoff is 1,326 mm and the maximum recorded instantaneous discharge (since gaging began in 1977) is 374 m<sup>3</sup>/s, measured during Hurricane David, August 31, 1979. As of 1995, approximately 65 percent of the basin is in pasture, 23 percent was forested, and the remainder was in crops and small clusters of houses.

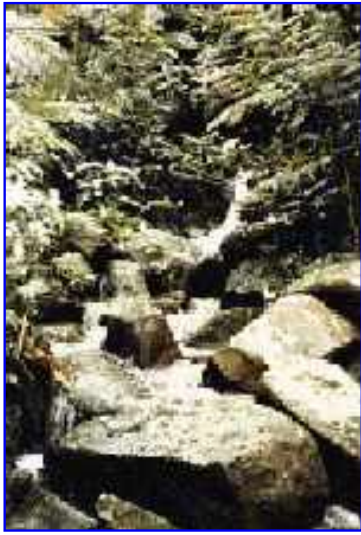
Tributary to the Rio Mameyes, USGS station 50065500.

This forested 17.8 km<sup>2</sup> watershed, located in the northeastern part of the Luquillo Experimental Forest, is underlain by volcanoclastic bedrock which weathers to massive boulders. Mean annual runoff is 2,798 mm and the maximum recorded instantaneous discharge (since gaging began in 1967) is 581 m<sup>3</sup>/s, measured during Hurricane Hugo, September 18, 1989. Average annual suspended sediment yields from this and comparable rivers in eastern Puerto Rico draining forested watersheds are typically 100 to 200 metric tons per square kilometer.

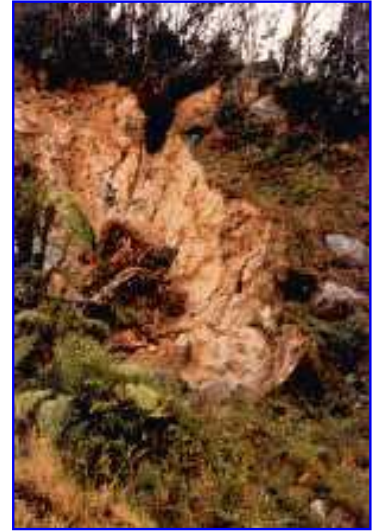
Landslide scar near PR Highway 191 in the Icacos watershed, Luquillo Experimental Forest. Note large quartz-diorite boulders, also known as core stones, imbedded in saprolite. Saprolite is *in situ* weathered or partially weathered bedrock.

Rainfall-triggered landslides are an important source of sediment exported by rivers in the Luquillo Mountains. Landslide debris contributes approximately 50 percent or more of the annual sediment yield of the Icacos and Mameyes river basins.
